The Perils of Restoring "Less Is More"

Krueck & Sexton architects faced tremendous challenges in the restoration of Mies Van der Rohe's 1956 masterpiece, S.R. Crown Hall, at the Illinois Institute of Technology

January 2006

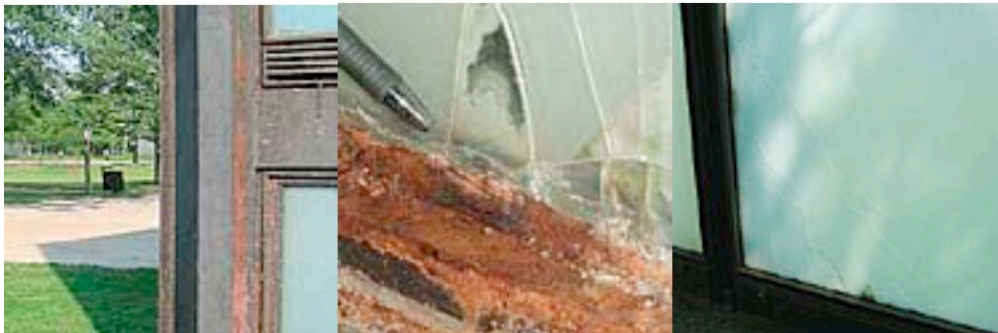
Steel corrosion was extensive. The repair cycle included sandblasting, inspection, more sandblasting, and repair. Steel conducted moisture along the base causing condensation in the winter. When the paint is damaged by moisture and exposes the steel to the elements, the steel rusts and forms a red dust (1 & 2). Corrosion pits form, which produce just enough pressure in the stop to crack the glass (2 & 3).

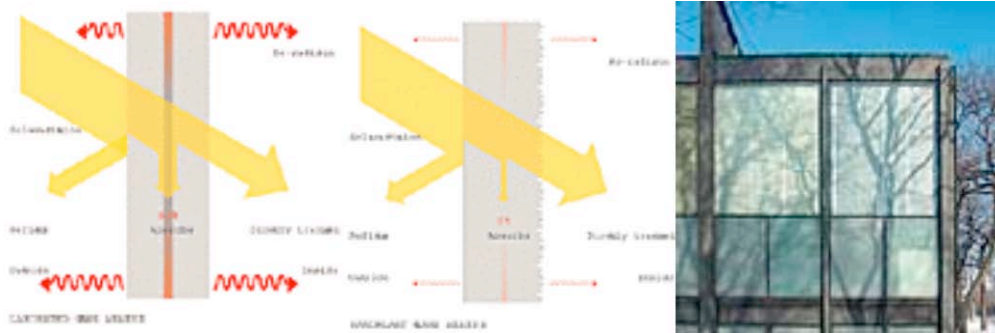
At least five full-size mock-ups (3) were produced to test several glazing options and the blind replacements. Studies of solar radiation transmission show the difference between laminated glass units (1) and single sandblasted panes (2).
