The Perils of Restoring "Less Is More"

Krueck & Sexton architects faced tremendous challenges in the restoration of Mies Van der Rohe's 1956 masterpiece, S.R. Crown Hall, at the Illinois Institute of Technology

January 2006

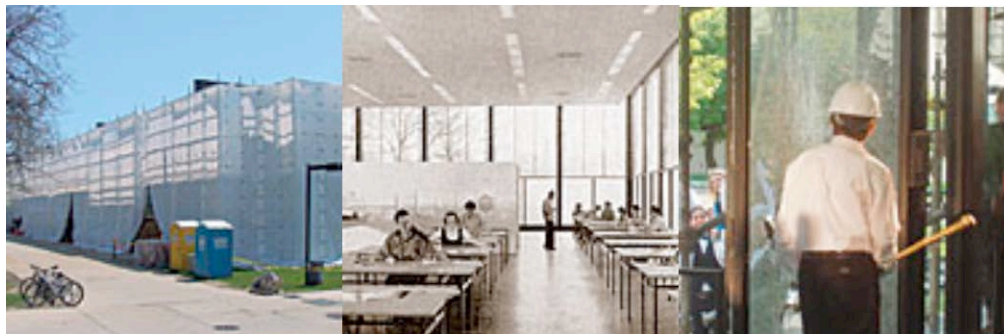
The contractor shrouded the entire building (1) to keep the dust from the lead-based paint from escaping into the environment. Students work at Mies-designed drafting tables in 1956 (2). Mies’s grandson, architect Dirk Lohan (3), ceremoniously launches the restoration by smashing one of the glass panels.

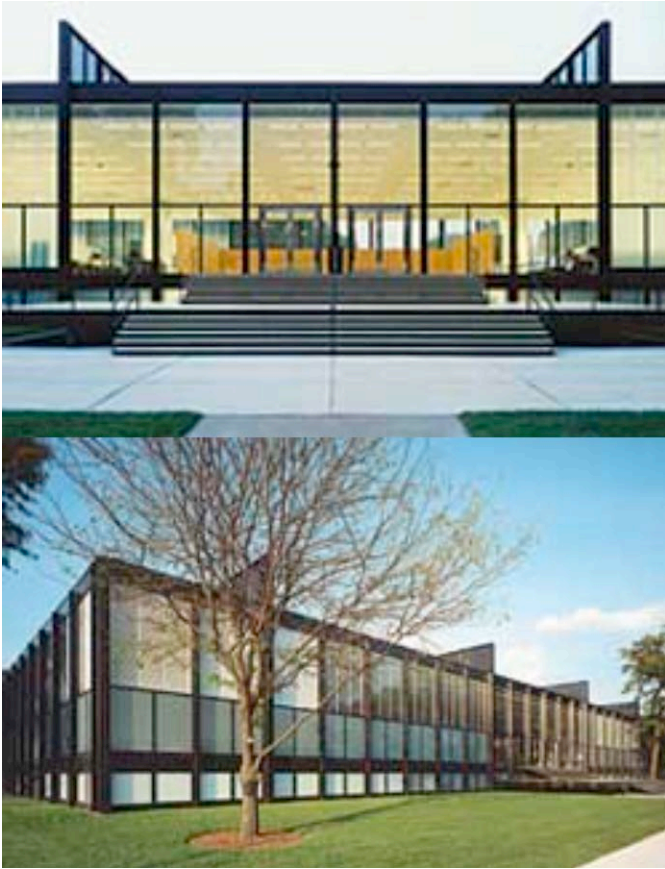
S.R. Crown Hall is returned to its original glory. Krueck & Sexton Architects and Clune Construction searched until they found a manufacturer to recreate the “Miesian black” that delineates the structure’s exoskeleton in stark contrast to the rest of the campus.

Finally, there was the issue of the paint. The sharp “Mies black” had faded to a dull gray. The original paint could not be used again, because it was lead-based. Product research led the architects to Tnemec, an industrial paint and coatings manufacturer known for products of extreme durability. The three coats that were applied should last about 25 years.
